New Concepts for Meadow Restoration in the Northern Sierra Nevada

Big Flat/Cottonwood Creek Project

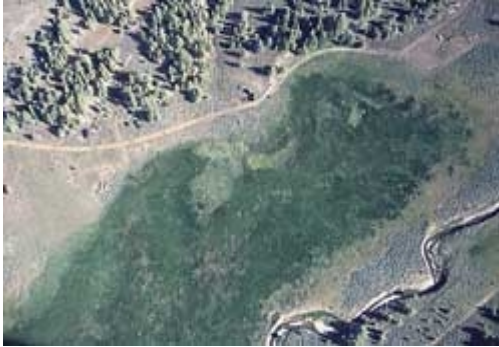
Figure 1: Aerial view of Big Flat Meadow prior to restoration.

To re-water Big Flat Meadow, the FRCRM developed an new approach that combines geomorphic measures, grazing management changes, and revegetation to meet project objectives (FRCRM 1996). Figures 1-2 presents an aerial view of the project before and after implementation of the preferred design.

Geomorphology: From a list of potential alternatives, the FRCRM selected a unique “pond and plug” restoration approach to return hydrologic function to Big Flat Meadow. This strategy involved abandoning the creek’s current incised gully. The gully was filled in with soil excavated from seven onsite ponds that were created for waterfowl and wildlife habitat enhancement. The creek was diverted into a reconstructed 4,050 foot channel sited in the historic location, and rock step pools were created in the steepest sections of the new channel to protect against new head cutting (Benoit and Wilcox 1997).

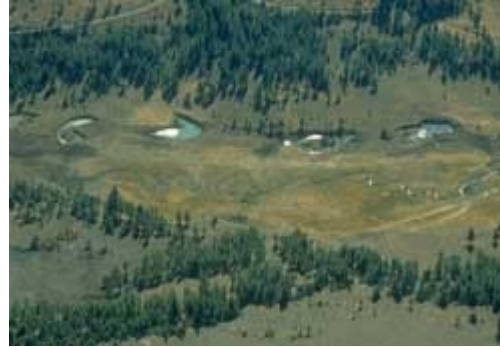
Figure 2: Aerial view of Big Flat Meadow after restoration

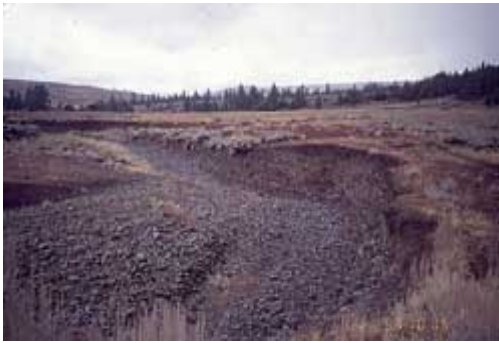
Figure 3: Cottonwood Creek prior to restoration

Established photopoints and field observation indicate a shift from a preponderance of undesirable dry site vegetation including cheat grass, sagebrush and rabbitbrush, to wet site species including sedges, hairgrass and bluegrass. Bare ground has been replaced with lush vegetative growth in most areas. Vegetation transect data will be available after the 1999 field season to quantify these observed results of the project. Figures 3-4 provides a before treatment and after treatment view of Cottonwood Creek.

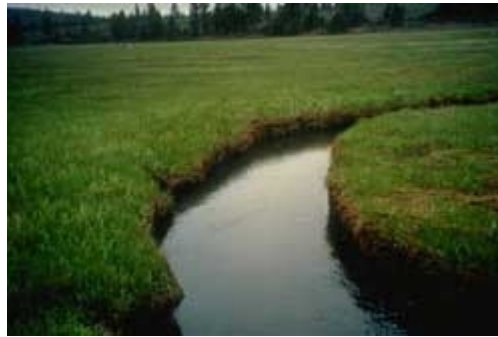
Figure 4: Cottonwood Creek after restoration
