## Results of the 2007 Bear Creek Video Station Fall-Run Chinook Salmon Escapement

By  
James Chichester  
Western Shasta Resource Conservation District  
Anderson, California  
35-31 Project Report  
2008

**Results of the 2007 Bear Creek Video Station Fall-Run  
Chinook Salmon Escapement<sup>1</sup>**

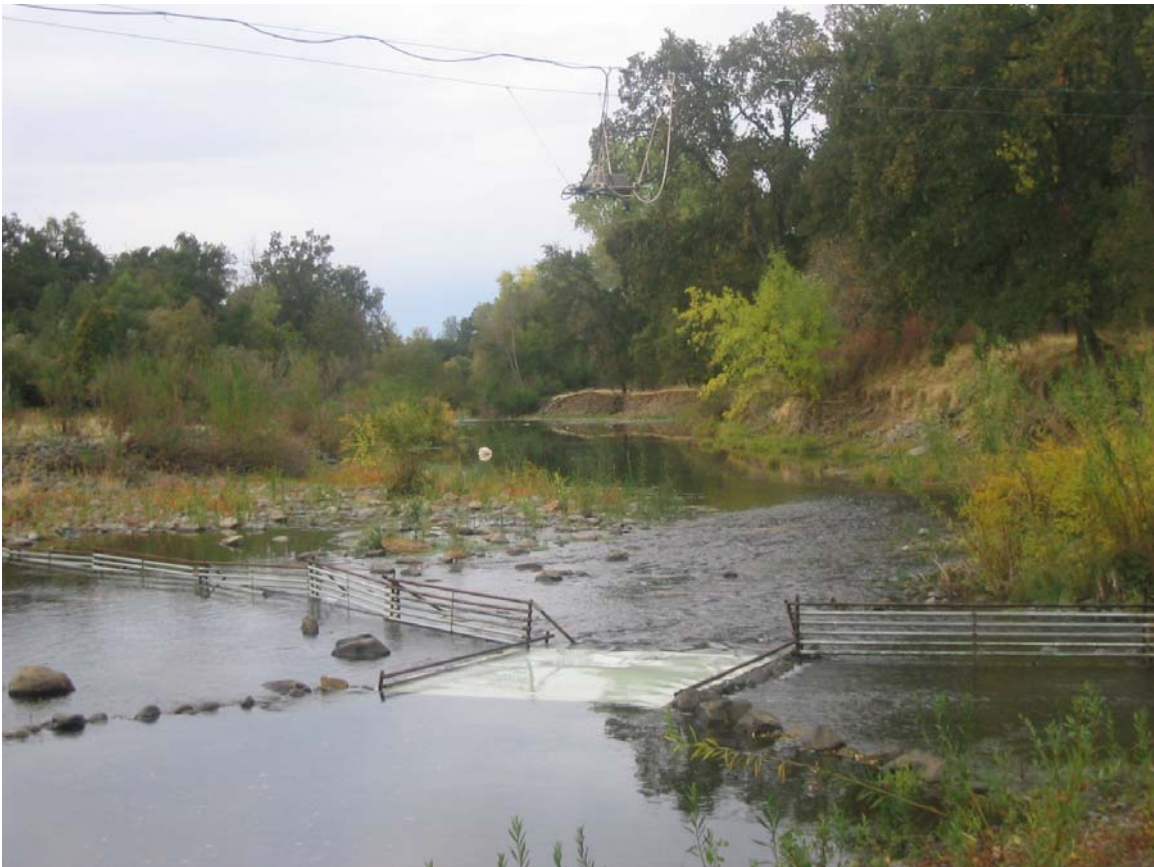
*Cover Photo: View looking downstream at the fish passage opening of the 2007  
Bear Creek Video Station*

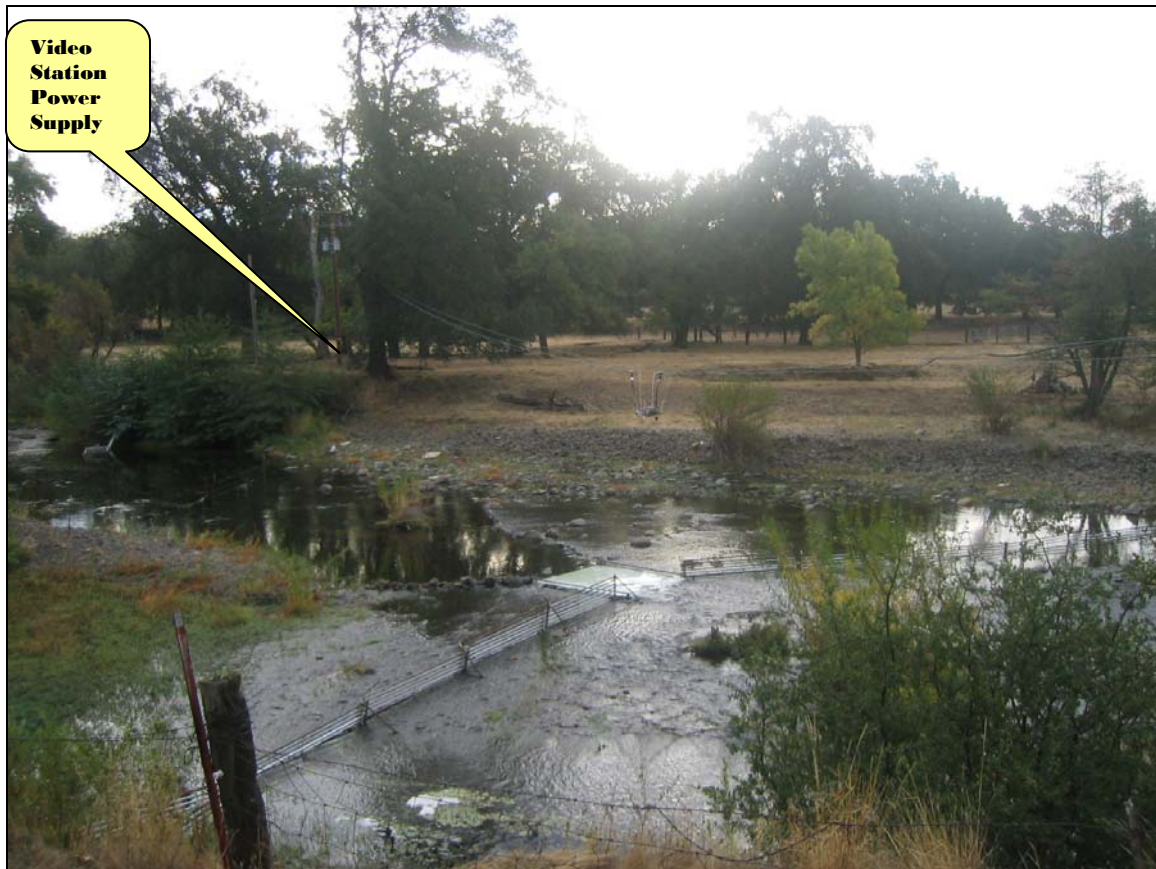
*Figure 2. Bear Creek video station power supply box. An active box was available to power the station. A 240 to 120 AC volt transformer was installed to provide standard household power to station equipment. Also showing is the two main cables used to suspend the overhead camera. The VCR lock box is located to the right (not shown).*

One criteria of the Bear Creek Video Station was that it be located near a conventional "on-grid" power supply. A site was located on the property bordering the south shore of Bear Creek with an existing 240 volt incoming supply box (Figure 2). This box was at the time used to power an electric irrigation pump in the creek. A 240 to 120 volt transformer was installed next to the existing box and provided a 120 volt household AC power supply to run the cameral lights and equipment.

The VCR lock box was set up on the opposite side of the creek that was accessible to vehicles. About 250 feet (76 m) of wire was run along the camera support cables to power the station's equipment.

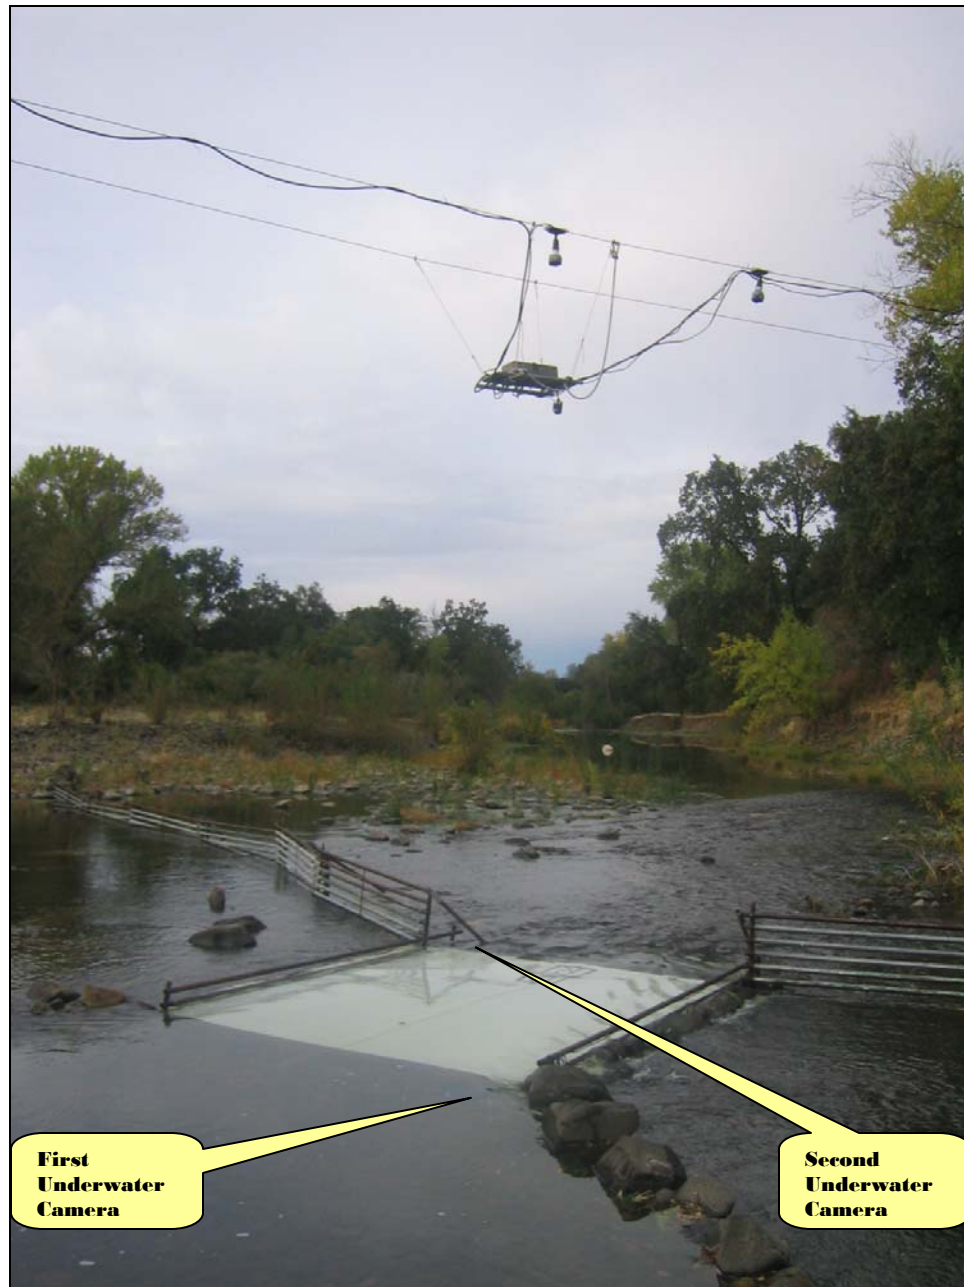
*Figure 3. Camera box suspended over Bear Creek at a height of about 12-feet (3.6 m) from the water's surface using a two main cable system constructed of 5/16-inch (7.9 mm) galvanized steel cables. Also showing the location of the two underwater cameras and the weir opening allowing fish passage.*

This camera box was suspended over Bear Creek at a height of about 12-feet (4 m) from the water's surface using a two main cable system constructed of 5/16-inch (8 mm) galvanized steel cables. The two main cables, about 200 feet (91 m) each, were stretched across the creek and anchored in two trees as shown in Figures 2 and 3.

Tightening of the main cables was accomplished with a mechanical “come-along.” The end of the main cable closest to the VCR-battery box was designed to allow easy movement up and down with the mechanical “come-along.” In this manner the camera was raised and lowered if an adjustment to lighting, or camera cleaning was required.

A weir was constructed to channel salmon into the camera's view without causing passage delay (Figure 3). The weir was constructed of 10-foot (3m) long steel 1 1/8 inch O.D. (28 mm) pipes which were welded to uprights with 3-inch (76 mm) spaces between pipes. Some taller panels used 1 1/4 inch EMT conduit on the inner cross members to lighten the overall weight of the finished panel. The 10-foot (3m) wide horizontal pipe panels were designed to fit the depth of Bear Creek at the station site (i.e. panels in shallow water had only 2 or 3 cross members while panels in deeper water had up to 8 cross members). The horizontal design and spacing between bars of the weir panels allowed leaves and sticks to pass through the weir while preventing salmon from passing the weir unmonitored. Panels were secured in place using rebar stakes and specially designed "dog leg" fittings developed by SRSSAP staff. The rebar stakes were pounded vertically through the panel uprights and into the stream bottom. The dogleg

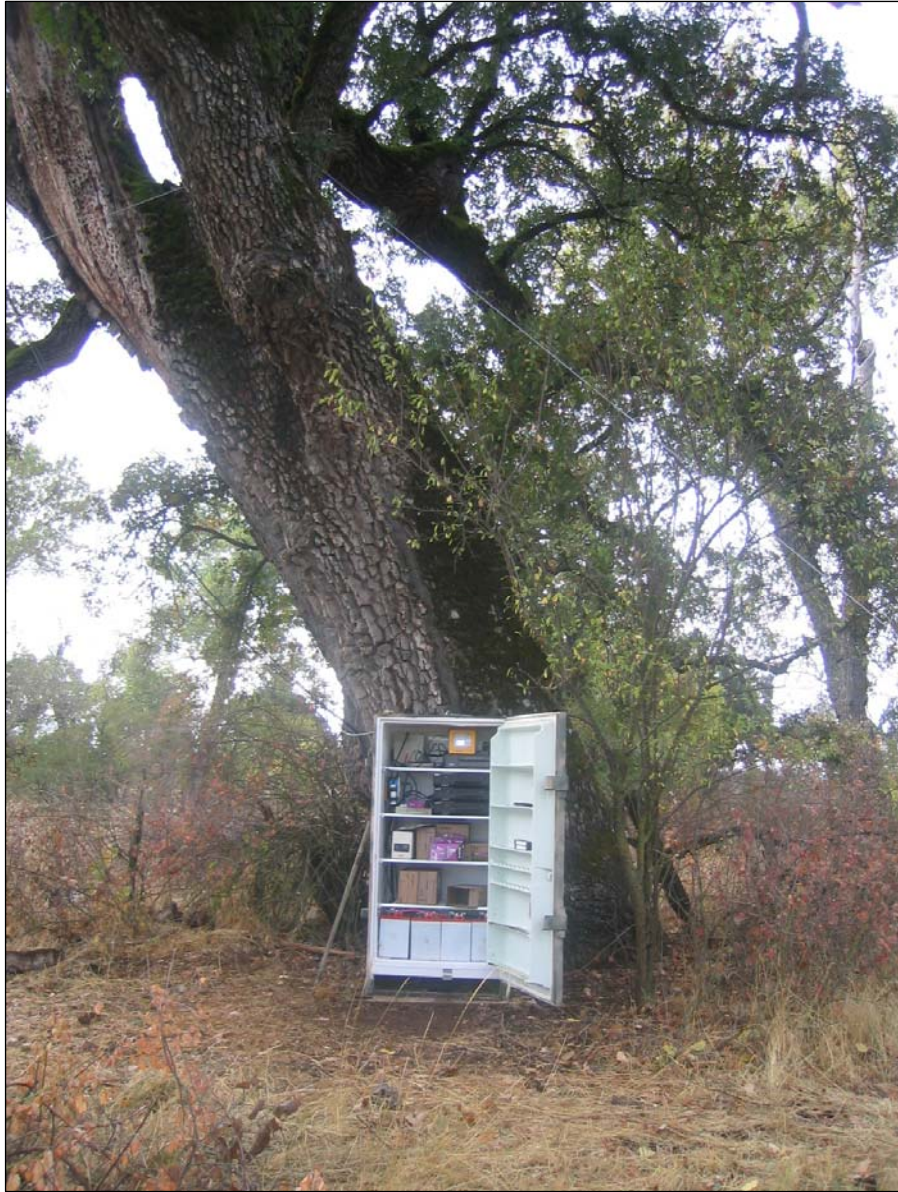
*Figure 4. The video station's VCR-lock box. The modified refrigerator contained the four VCR's, the quad processor, the power controls, equipment and tape storage boxes, monitor and batteries. The cable above the lock box is the anchoring cable to the two main cables suspending the overhead camera over the creek.*

The camera box was attached by ropes to the main cables which reduced vibrations caused by wind. The camera was connected by co-axial (RG-6) cable to the station's VCR-lock box, which was located about 50 feet from the creek, above the flood plain. Power cords and camera co-axial cable were wired to one of the overhead support cables with short sections of insulated wire. Figure 4 shows the refurbished refrigerator used to secure and shelter the station's video equipment, electrical accessories and batteries:

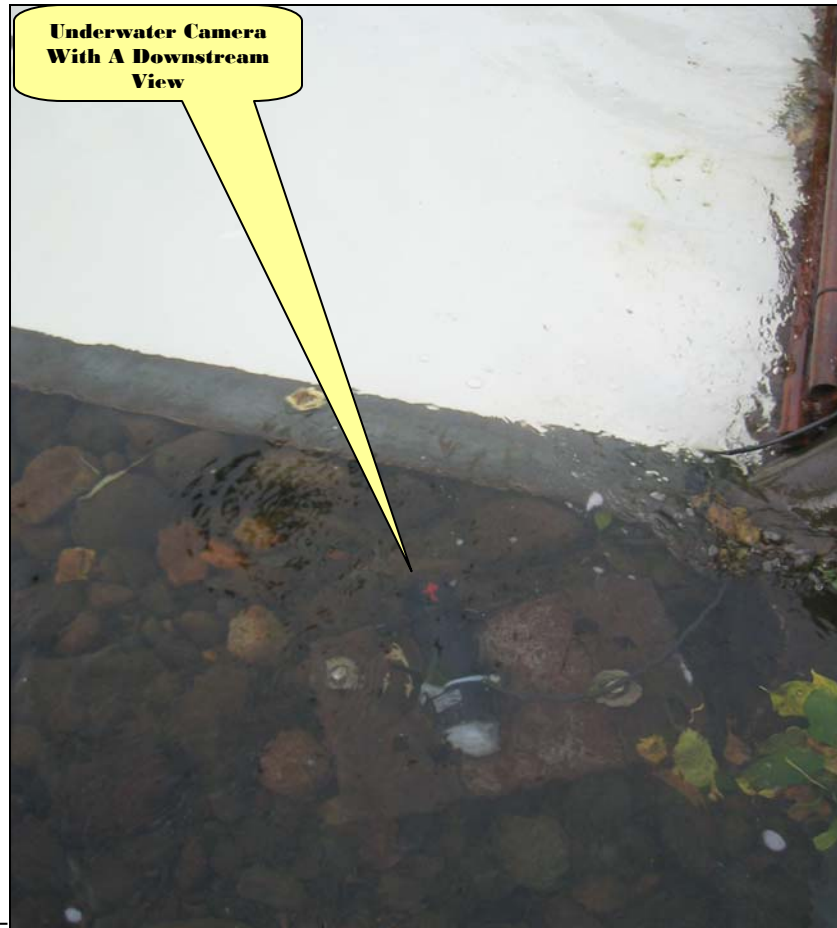
*Figure 5. The underwater camera is the same type as the overhead camera (PC88WR). Installed at the upstream end of the background plates, the underwater camera was useful for monitoring the movement of the fish up or down stream as well as for species identification.*

An underwater camera was installed at the upstream end of the background plates (Figures 3 and 5). This camera was the same type and cost as the overhead camera (PC88WR black and white). The underwater camera was useful for monitoring upstream and downstream movement and for species identification. From the overhead camera it

The camera was installed inside a custom-made PVC capsule. The capsule had to be built of high grade material for protection and sealed to not allow water inside of it. To ensure it would withstand the current, the capsule was strapped to a 20 pound metal plate and the metal plate anchored to the creek bed. The camera's co-axial cable ran atop the weir panels and once out of the creek it was buried underground to the lock box to prevent vandalism and provide an appearance suitable for the area where the station was located. Towards the end of the monitoring season a second underwater camera was installed at the right entrance to the weir (Figure 3). The design and installation followed the same criteria as the first camera. This camera became available to use on the Bear Creek video station after the Cottonwood Creek and Cow Creek video stations had been removed. The second camera allowed a second monitoring angle necessary to accurately record and identify the movement of fish during the time when the water became turbid, due to increasing flows, and had poor visibility.

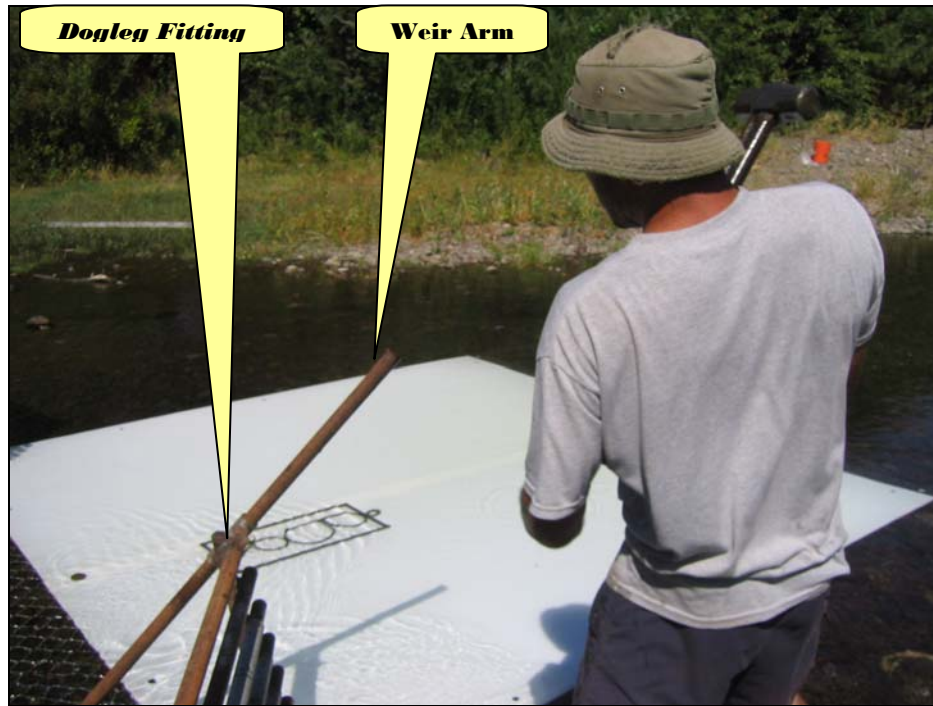
*Figure 6. The construction of the weir. The dogleg fittings were bolted to the uprights and a “weir arm” was slid through the fitting and pounded into the stream bottom at a 45 degree angle downstream.*

fittings were bolted to the uprights and a “weir arm” was slid through the fitting and pounded into the stream bottom at a 45 degree angle downstream (see Figure 6).

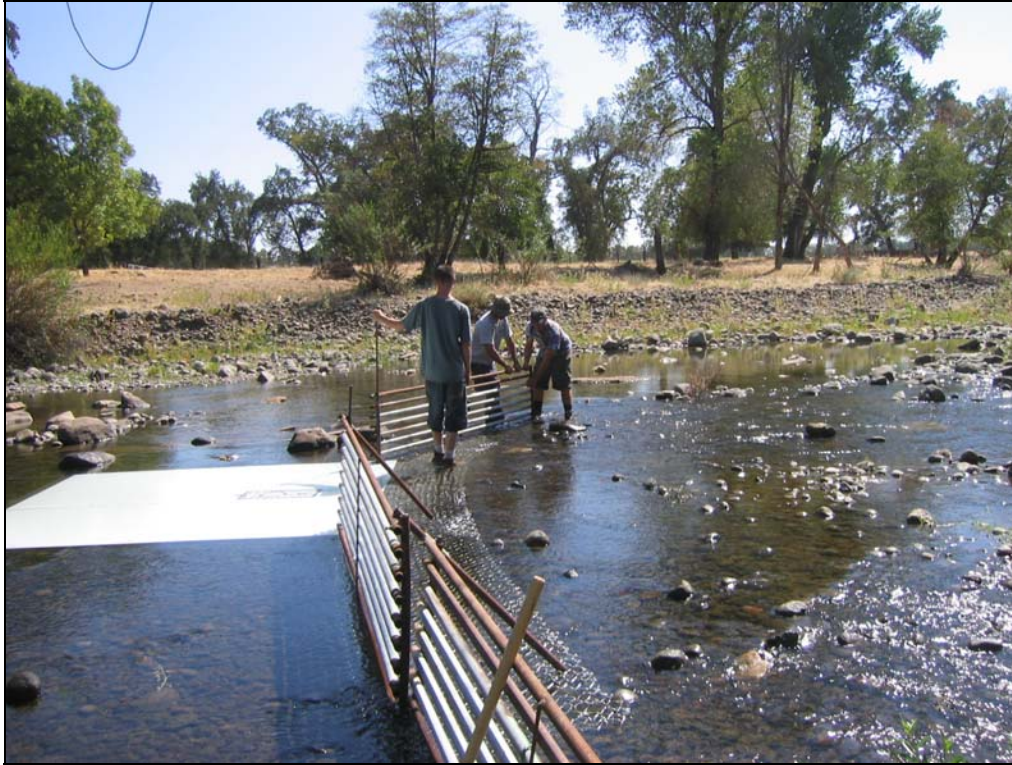
*Figure 7. The Bear Creek partial weir showing: the construction of the weir, including the white high density polyethylene (HDPE) sheets staked to the creek bottom to make the observation of passing salmon easier.*

White high density polyethylene (HDPE) sheets were staked to the creek bottom to make the observation of passing salmon easier. Two overlapping  $\frac{1}{4}$  inch by 5-feet by 10-feet (6 mm x 1.2 m x 3 m) sheets were used to create a white background (see Figure 7). These sheets had  $\frac{3}{4}$ -inch (19 mm) holes drilled around their perimeters to allow staking. A metal frame plate was bolted to the upstream edge of both sheets prior to placement in the creek. The entire assembly was then staked to the streambed underneath the camera. Stakes were 24-inch (61 cm) concrete form stakes with a 2-inch (50 mm) washer welded to their tops to secure the sheets.

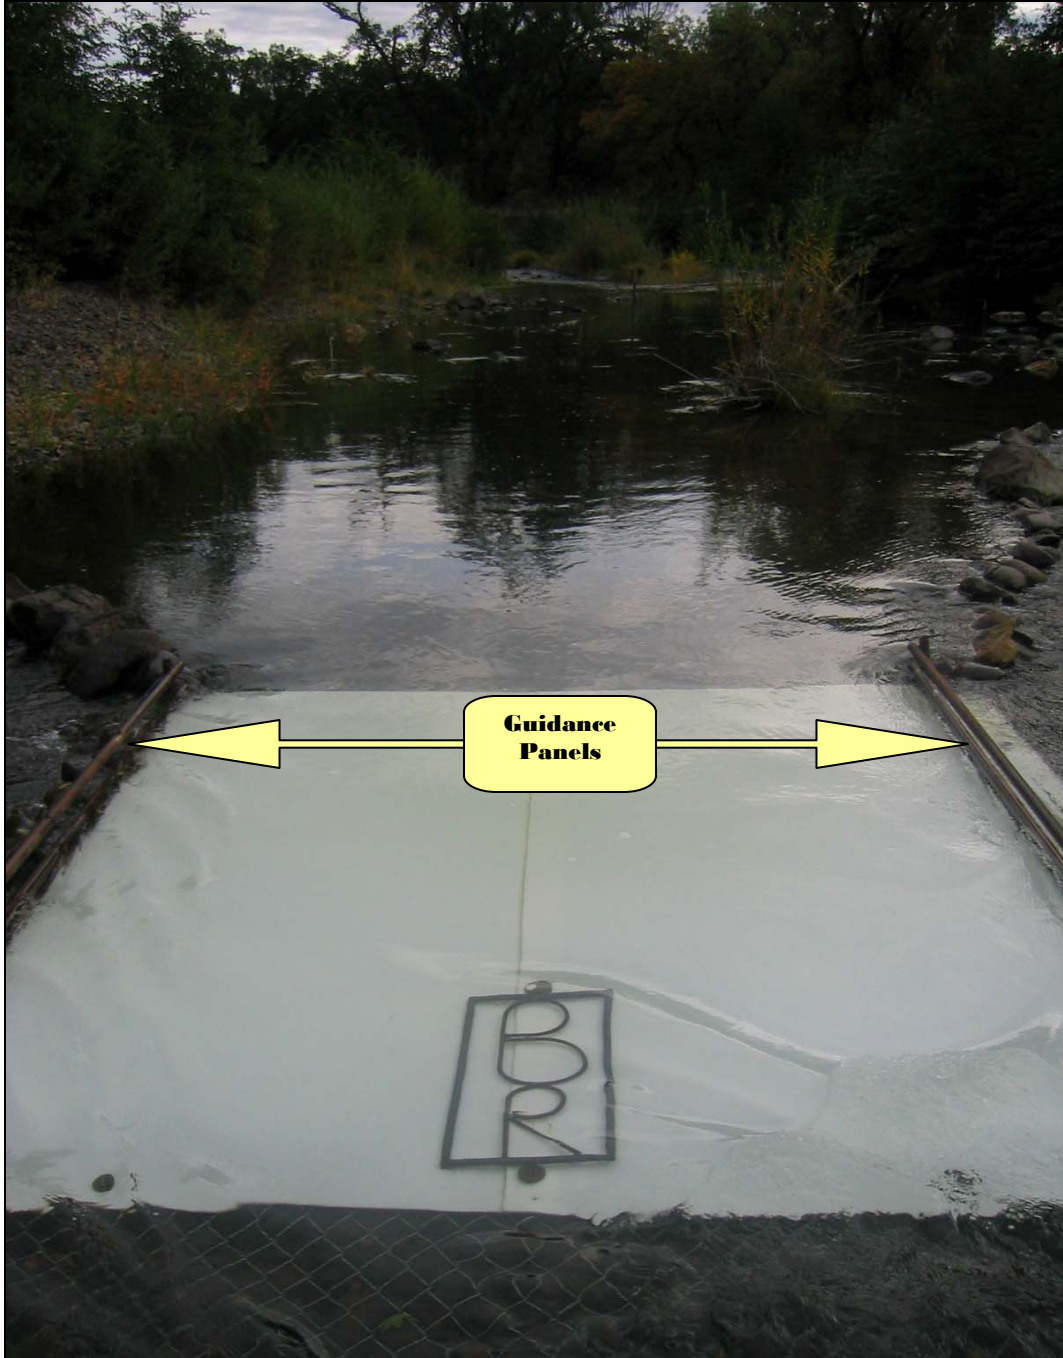
*Figure 8. A metal rectangle measuring 24-inches (61 cm) tall by 12-inches (30 cm) wide allowed tape readers to approximate fish lengths as well as identify the creek by its code name: BR= Bear Creek. Two weir panels were added as upstream facing guidance panels along the fish passage opening to prevent fish from skirting around the ends of the weir.*

Two weir panels were added as upstream facing guidance panels along the fish passage opening to prevent fish from skirting around the ends of the weir (see Figure 8). These guidance panels were placed along the outside edges of the white bottom plates just above the water surface and resulted in all fish swimming upstream along the entire length of the plates allowing for easier counting compared to similar weirs without these guidance panels (i.e. as found in the 2003 Battle Creek study, (Killam 2006)).

A measuring device was constructed to allow tape readers to approximate the length of passing fish. A metal rectangle measuring 24-inches (61 cm) tall by 12-inches (30 cm) wide allowed tape readers to approximate fish lengths, (see Figure 8). This “station brand” was designed and custom welded (by Doug Killam, D. S., CDFG) from  $\frac{3}{8}$ -inch (9.5 mm) rebar and incorporated the letters B and R into the center of the design. During future viewing tape readers will be able to identify tape images by the creek’s code name: BR= Bear Creek, (Figure 8).
