This Watershed Analysis is presented as part of the Aquatic Conservation Strategy adopted for the President's Plan (Record of Decision for Amendments to Forest service and Bureau of Land Management Planning Documents within the Range of the Northern Spotted Owl, including Standards and Guidelines for Management of Habitat for Late-Successional and Old-Growth Related Species).

This document follows the format provided in Part 2 of *Ecosystems Analysis at the Watershed Scale: Federal Guide for Watershed Analysis - Version 2.2* (August, 1995). This format consists of six steps:

Squaw Creek Watershed Analysis

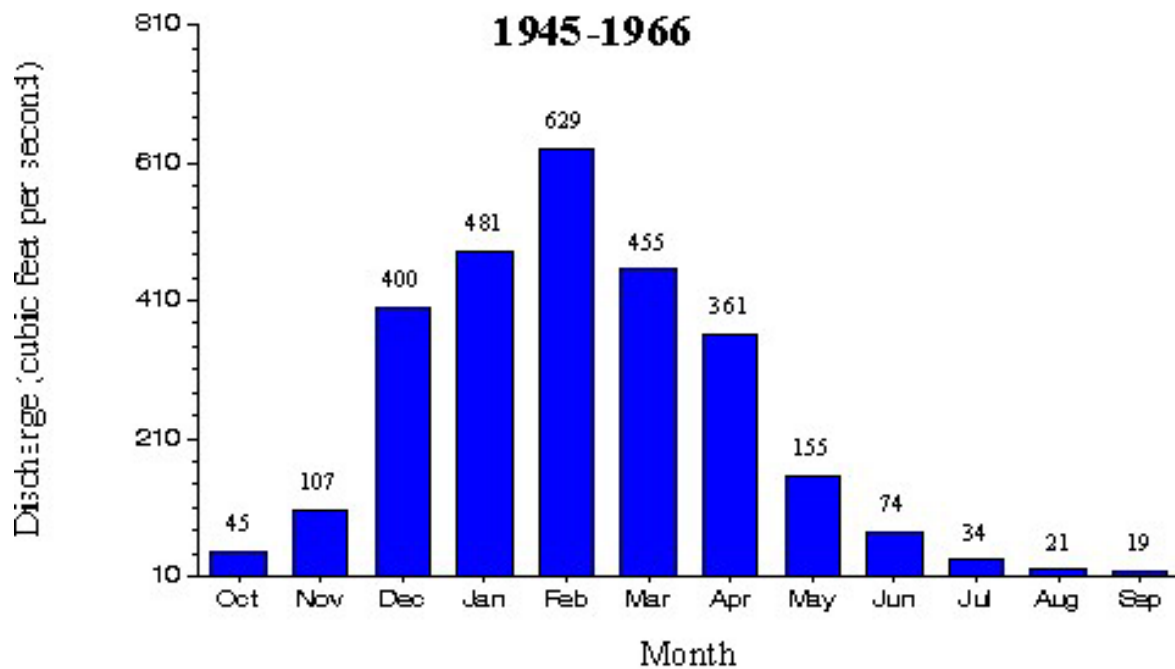
Figure 3-2: Average Monthly Base Flows for Squaw Creek at Station 11365500.

Average Monthly Base Flows for Squaw Creek above Shasta Lake.

Average monthly base flows for Squaw Creek are presented in Figure 3-2. Base flows are highest from December through April and decrease sharply from July through October in most years. Due to the highly variable nature of winter precipitation in Northern California, considerable variations in average monthly base flows occur from year to year. Considerably less variation occurs from July through September when precipitation is scarce.

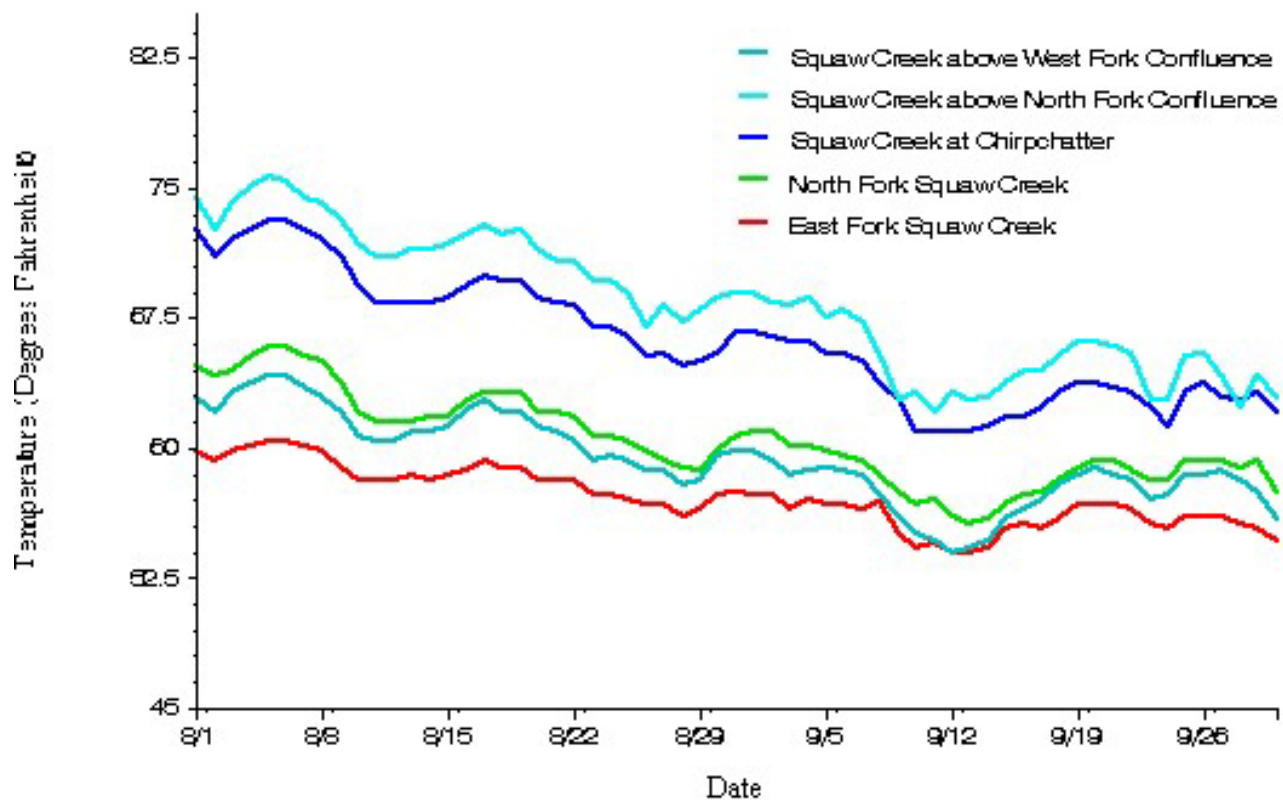
Figure 3-4: Maximum daily water temperatures for Squaw Creek and selected tributaries.

Maximum Daily Water Temperatures - August and September, 1994

Natural processes and land-use activities that remove vegetation such as wildfires, mass-wasting, timber harvest, and road construction can affect water temperature by removing vegetation and increasing the exposure of surface water to sunlight. Changes in water temperature due to the removal of the forest canopy can last for several decades. Water temperature recorders were placed in Squaw Creek and selected tributaries during 1994 and 1997 to collect base line data and to determine downstream trends in water temperature. The maximum daily water temperatures for Squaw Creek and its East and North Forks are shown in Figure 3-4. The highest temperatures were observed in Squaw Creek at Chirpchatter Campground and above the North Fork confluence. High temperatures were measured on July 20th, 1994 when the water temperatures in Squaw Creek at Chirpchatter and above the North Fork peaked at 77.2 and 78.8 degrees Fahrenheit, respectively. The lowest maximum temperatures were observed in the upper reaches of Squaw Creek above the West Fork of Squaw Creek and in the tributaries. On July 20th maximum temperatures in upper Squaw Creek, the East Fork and the North Fork were 61.2, 69.0 and 62.1 degrees Fahrenheit, respectively.

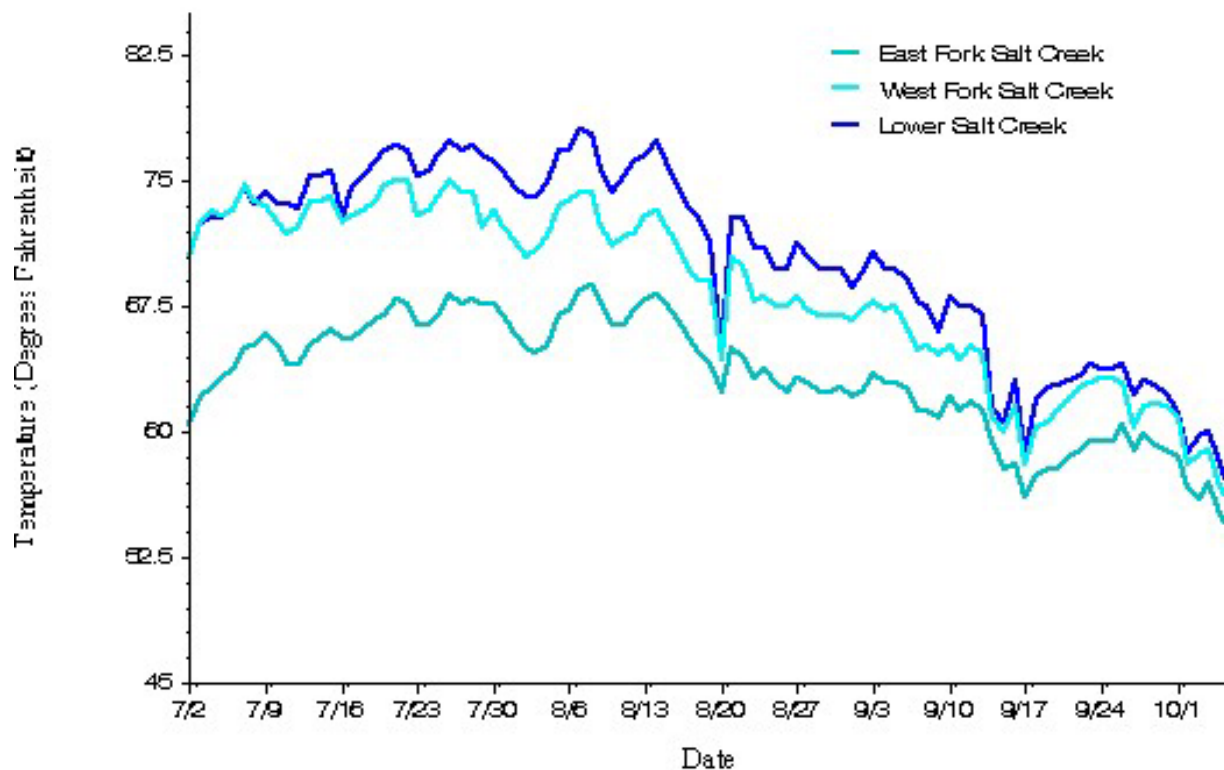
Figure 3-5: Maximum daily water temperatures for Salt Creek and tributaries.

Maximum Daily Water Temperatures - August and September, 1994

Water temperature data for Salt Creek and its East and North Forks were collected during the summer of 1997 in order to monitor the effects of a large debris flow which removed much of the stream shading canopy on the West Fork of Squaw Creek (Figure 3-5). Water temperature data show that the debris flow impacted West Fork of Salt Creek had higher water temperatures than the East Fork of Salt Creek. While the effects of the reduced canopy cover appear obvious, the discrepancy in water temperature between the East and North Forks may also be due to other factors including differences in tributary drainage areas, water residence times and differences in the amount of timber harvest and roads occurring in each tributary.
